Objectives of Beach Monitoring

Port Fairy Coastal Group

PFCG
October 2017.

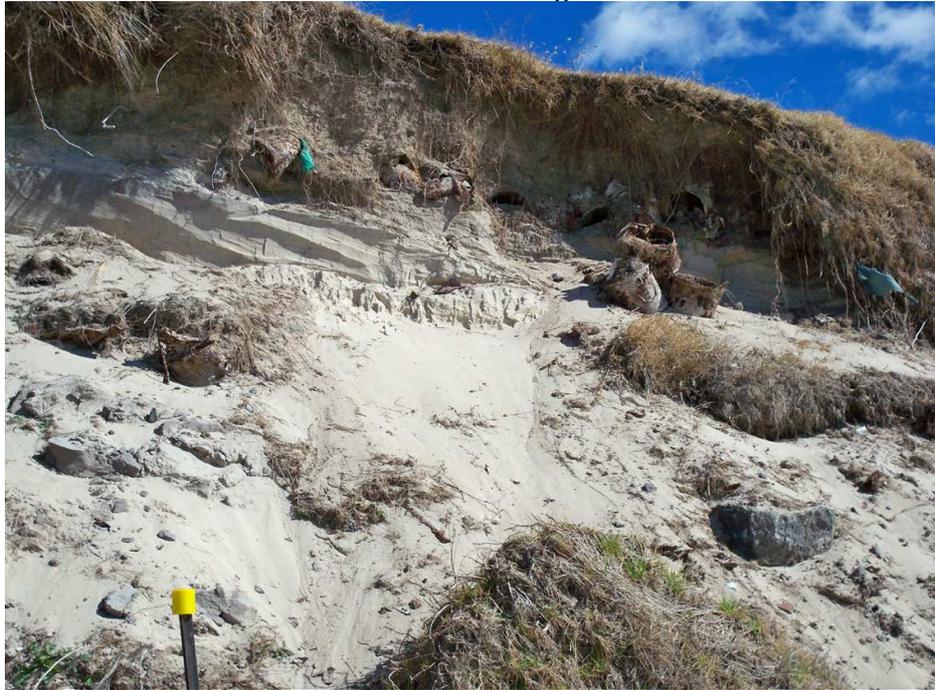
Erosion at the former Night Soil site

Dramatic scenes like this distracted public interest from investigating potentially more serious erosion in other parts of the beach.

Unfortunately, hard rubbish was also dumped here prior to the site being closed and was solely responsible for creating such a poor public regard for this area. Soil and water tests show no contamination from the biodegradable material but the exposure of hard rubbish was unsightly as the dune face recessed.

Reshaping of the dune face together with Enviro matting and a double sand fence along with extensive natural vegetation have eliminated major dune recession at the former Night Soil site, now under the control of DELWP.

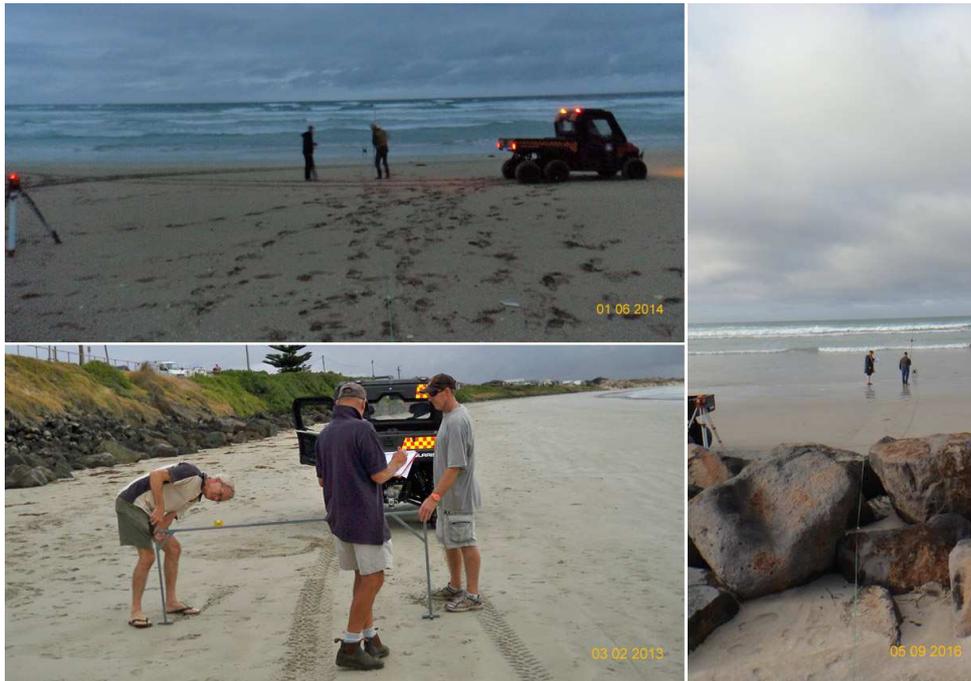
Coastal Group Beach Monitoring volunteers at work

The Port Fairy Coastal Group conducts beach monitoring all year round and during the winter months that usually means commencing while it is still dark, always cold and sometimes wet. Collecting measurements on the beach is time critical because more measurements can be made when the tide is lowest, so the cold wet early start on a winter Sunday morning is necessary in order to recover the most useful data. Such is the community spirit and dedication of the Coastal Group members.

After years of measurements, we have discovered that very useful data comes from a point at least 30 metres seaward of the reference post where the beach is rarely out of water and subjected to wave action for much of the time.

Volunteers often make their own purpose built measuring equipment including the mechanical frame being evaluated here to measure beach profiles. Further testing found that a builder's laser level was more suited to the large number of measurements needed and the Moyne Shire supplied the group with a dedicated laser level. The laser level is a key piece of equipment for beach monitoring and is used for all profile measurements. The Moyne Shire also provides additional support to the Port Fairy Surf Lifesaving Club for the use of their beach vehicle to transport the monitoring team and equipment around the 4.5 km of the East beach coast.

Along most parts of East Beach, it is usually possible to achieve a distance of 30+ metres from the reference post for the transverse profile but in front of the WEDs and beyond to posts 11 and 12, members often have water levels at knee height before reaching the magic 30 meter distance.

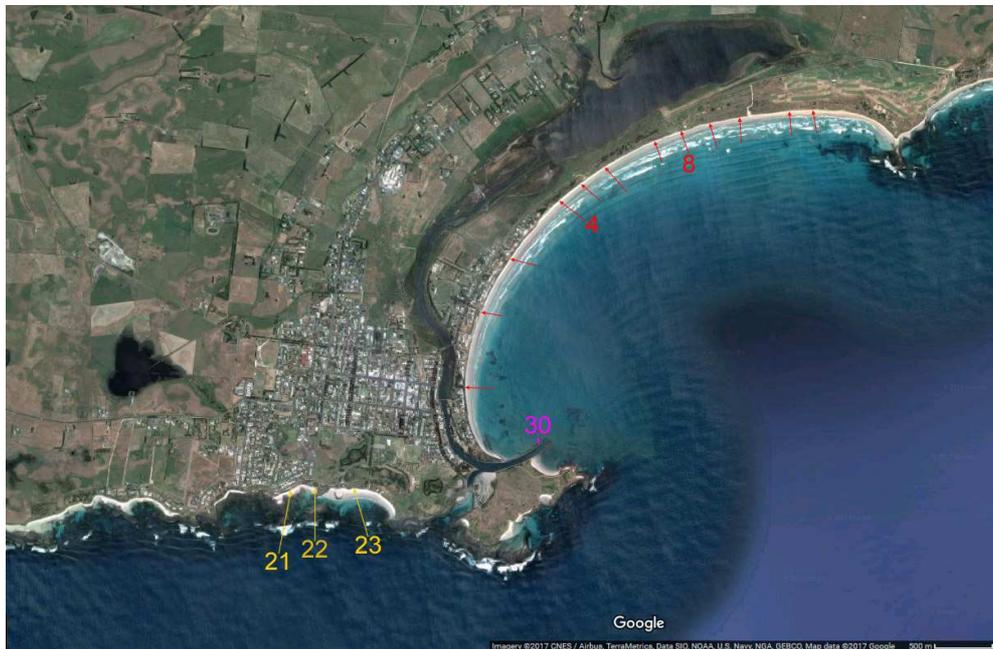
PFCG Reference Points on the Port Fairy Coast

East Beach at Port Fairy Bay has fourteen surveyed reference posts of which twelve are used in the measurement of sand profiles on the beach. Post 4 currently has the highest sand level at a dune face and post 8 is in front of the dunes containing the former tip site.

Note the visible wave and swell activity centred around post 8.

Posts 21, 22 and 23 are used to monitor popular parts of the South coast beaches.

Reference point 30 will be used for sand level surveys in the bay itself.

The Google image of the coast on page 4 confirms high wave activity in this area.

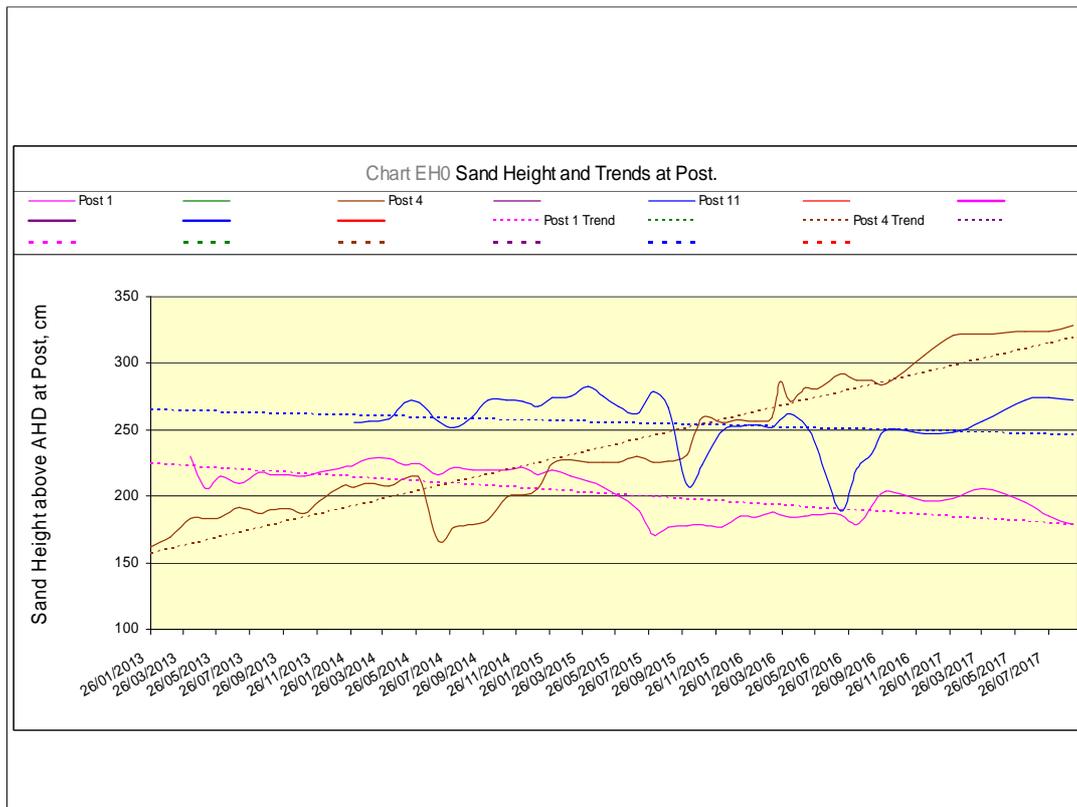
Linear Trend Analysis takes account of the complete known history of sand height at the post and provides an estimate of the net accumulation of sand at that point.

Information about the sand height trend for each post is collected and used to summarize trends on the next page.

In future revisions of the spreadsheet of data, evaluation of the height trend will be available at other distances from the reference post and principally from the 30m distance as this is proving to be the most active part of the foreshore currently being monitored.

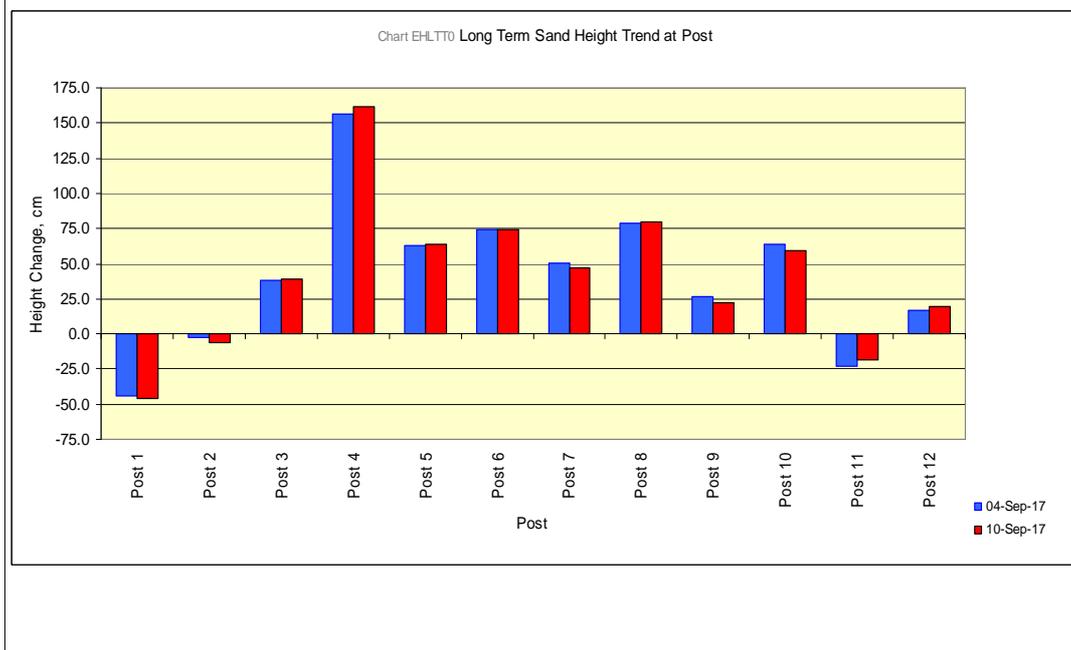
Changes in Sand Height Trends provide early warning of new beach conditions

This analysis has only just been introduced although it is based on all measurements since March 2013. Detailed trend analysis will be extended to other distances from the post as we develop the mathematics to help understand our beach sand systems.

The long term monitoring of sand height at the posts provides data on the overall rate of accretion or decline of sand levels on the beach. High sand levels reduce the impact of wave surges on erosion of the dune face by its presence as a physical barrier and as an energy absorber when some of the sand is washed away.

Given the location of post 8 in a part of the beach subjected to higher wave activity, its non conformance with the adjacent posts is attributed to it being protected by the Wave Energy Dissipation structure. (WEDs page 13)

Post 4 shows a very high rate of accretion at the dune face. This additional sand is deposited by wind action and is centred at the post close to the dune face but at a distance of 10m in front of the post and beyond, sand levels resume normal beach height. This is evidence of wind blown sand and means a loss of sand from some other location.

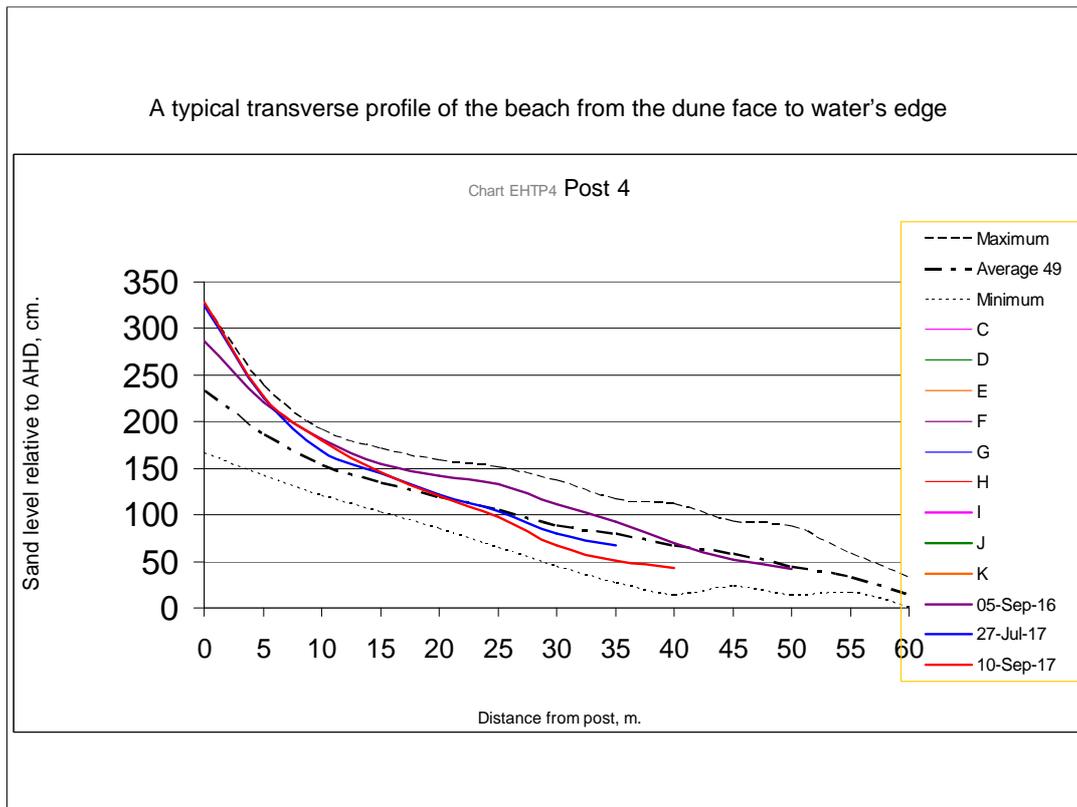
Transverse profiles are measured at thirteen locations around East Beach and three locations at South Beach. A beach profile shows the sand height from the post near the dune face to near the water's edge. All heights are referenced to the Australian Height Datum by way of the surveyed reference post where its height above the datum has been previously measured.

Profile charts are used to gauge how much of the beach is accessible with dry sand and by coastal engineers to assess sand volumes.

In order to provide the clearest representation of the beach condition, only three profiles are plotted on a chart; they are the last measurement, the previous measurement and a measurement from about one year ago. This gives an immediate assessment of the current change and how the situation is tracking compared to last year.

The current position in relation the average reading is also available. In the chart data for post 4, 50 readings have been made and the first 49 readings have been used to calculate simple statistics of minimum, average and maximum values of sand height. These statistical values are plotted with dotted lines and form an 'envelope of limits' within which normal beach values will plot. If a new reading plots beyond the envelope, it is readily detectable and can be investigated for a special cause event.

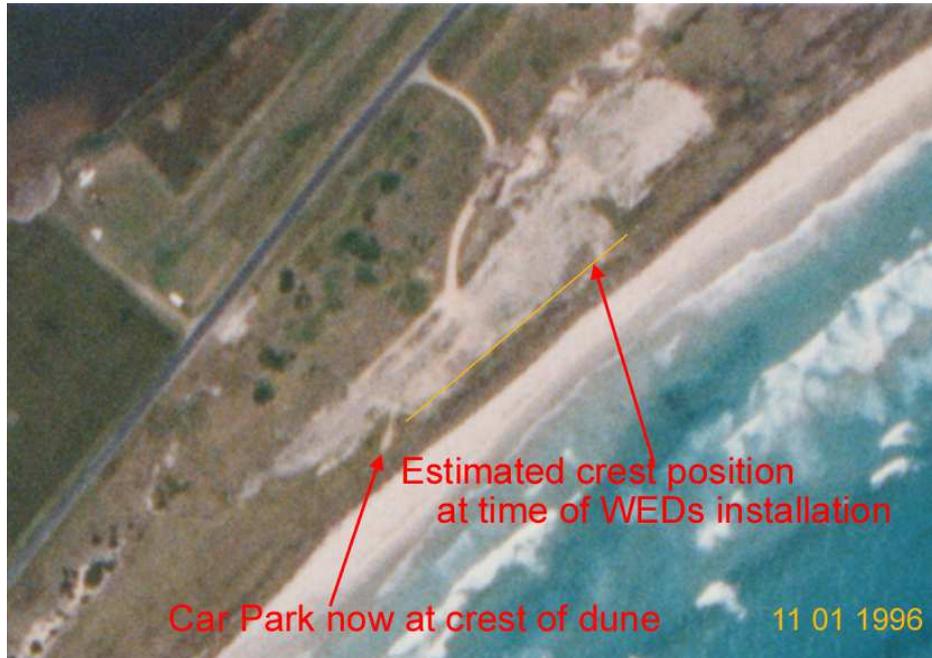
Wave Energy Dissipation structure halts dune recession

Parts of the coast in Port Fairy Bay have been measured to have an actual dune recession rate equivalent to 1 metre every year since this photograph was taken in January 1996.

Although many years after the tip was closed, the outline of the tip area was still visible and it shows just how close the dune face came to exposing buried waste.

The yellow line indicates the estimated position of dune recession just before the protective rock barrier was installed in front of the old tip site. We know this point very precisely because the car park was surfaced with a yellow road base material. This residual yellow material has been clearly visible just below the dune crest as it receded and the yellow road base ends up on the beach, providing the clues to how much of the dune has been removed since the photograph was taken.

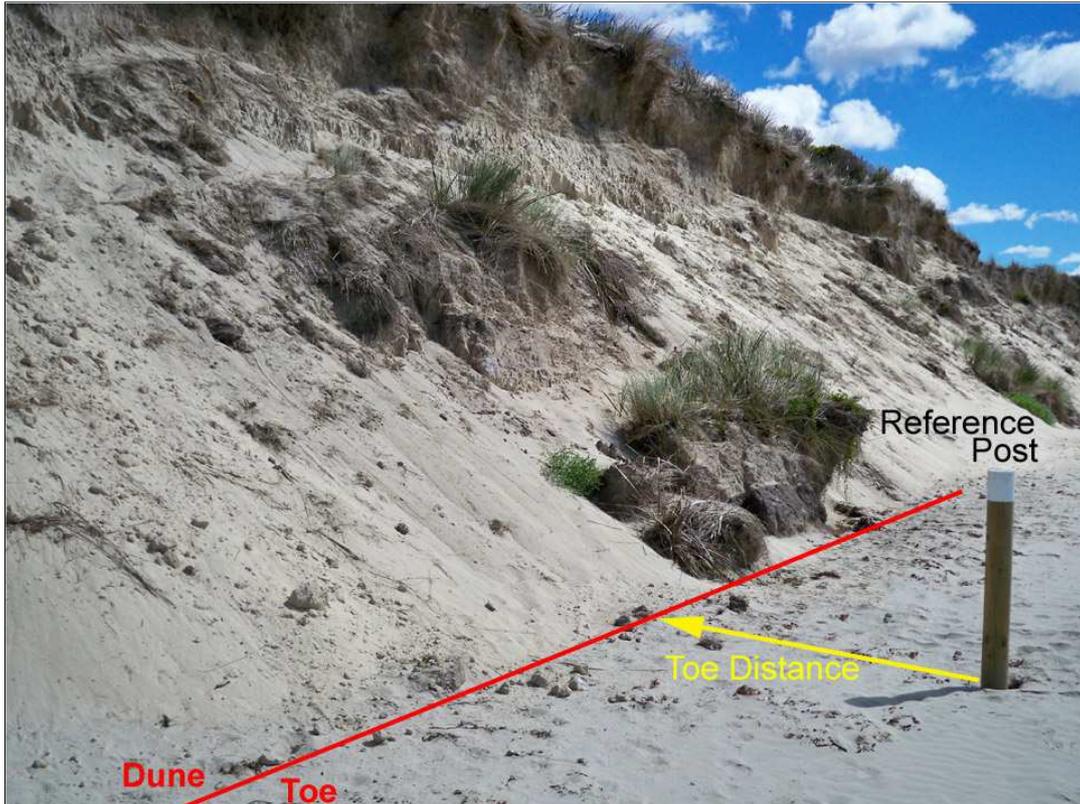
This was reference post 8 in front of the old tip site prior to the construction of the rock wall and is a typical scene for most of the East Beach reference posts.

Water erosion by wave action starts at the toe and undermines the dune face. Sand then slumps down the face to replace the sand washed away. Eventually, the crest of the dune is undermined to such an extent that the dune crest shears off and migrates down the dune face to be eventually washed away. The dune face slumps at an angle between 30 and 40 degrees to the horizontal depending on grain size and moisture content. Erosion of the dune face is also caused by wind action and dune recession can still occur albeit at a much lower rate than with water erosion.

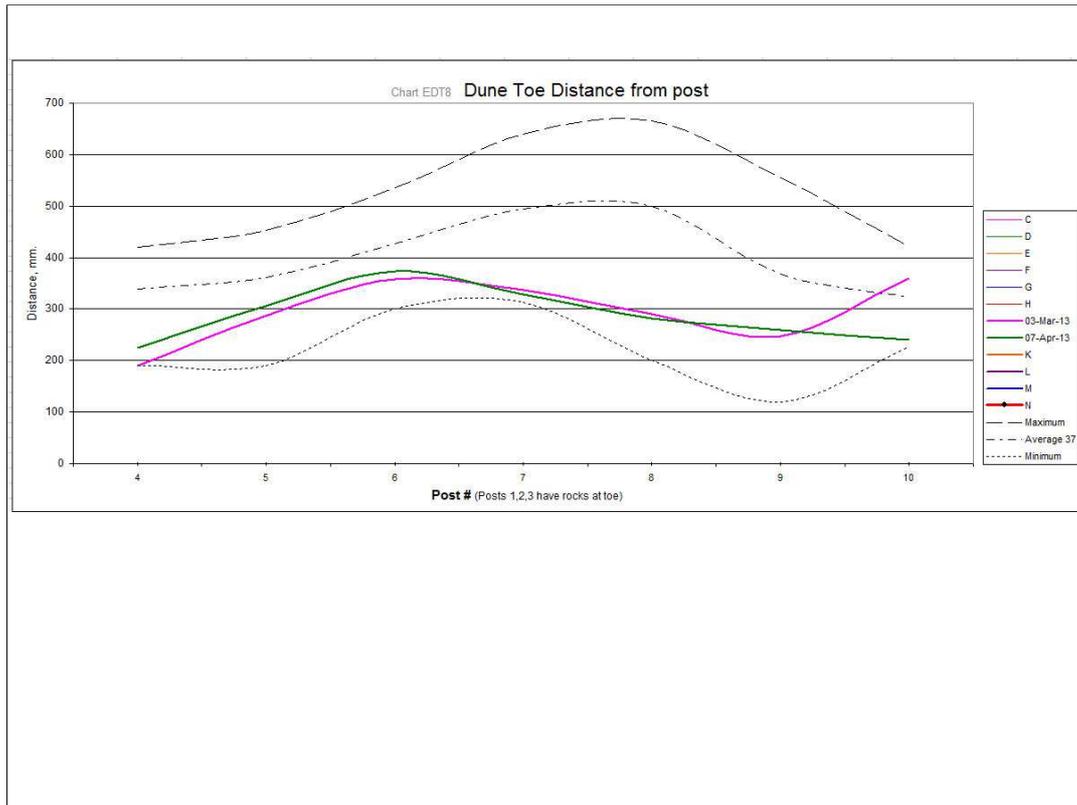
Measurements of the dune toe distance commenced in march 2013 and are shown above for those posts in front of a dune toe. A second measurement one month later confirmed stable toe distances except for post 10 where a slumping event caused a reduction in the toe distance.

The dotted lines represent the extreme and average distances ever measured for dune toe distances.

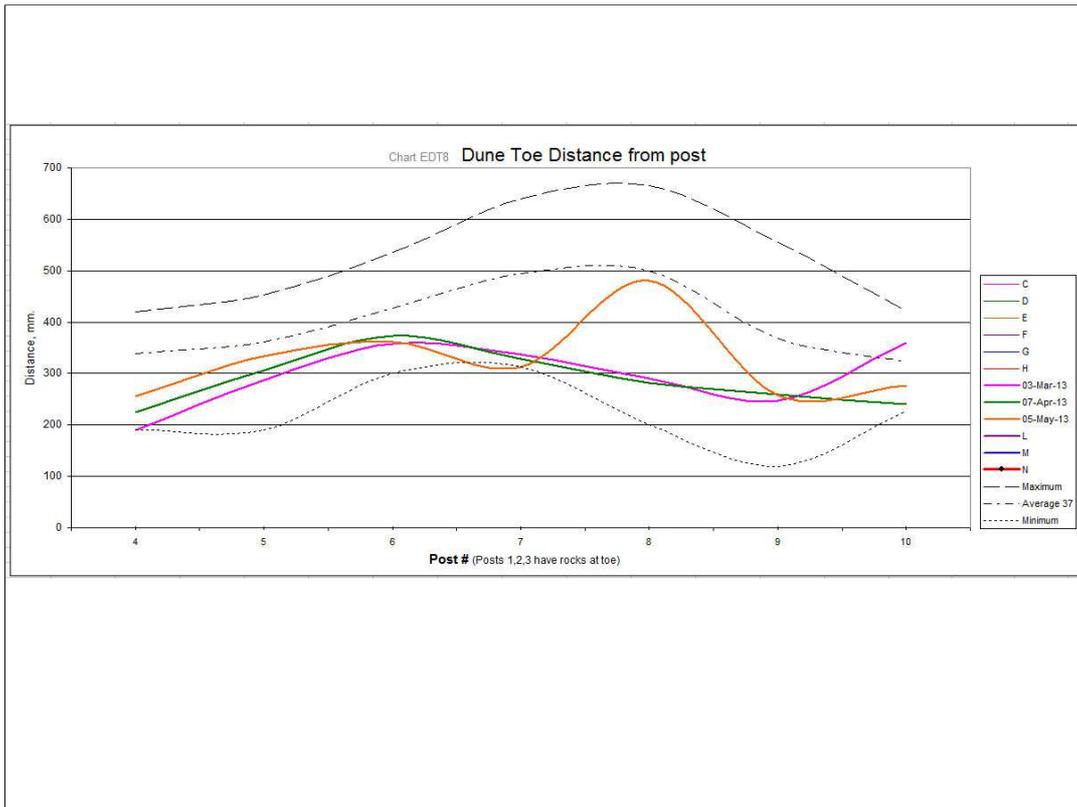
In May of 2013, the situation appeared to change dramatically when the toe distance at the former tip site (post 8) jumped by about 20cm. Monthly monitoring continued.

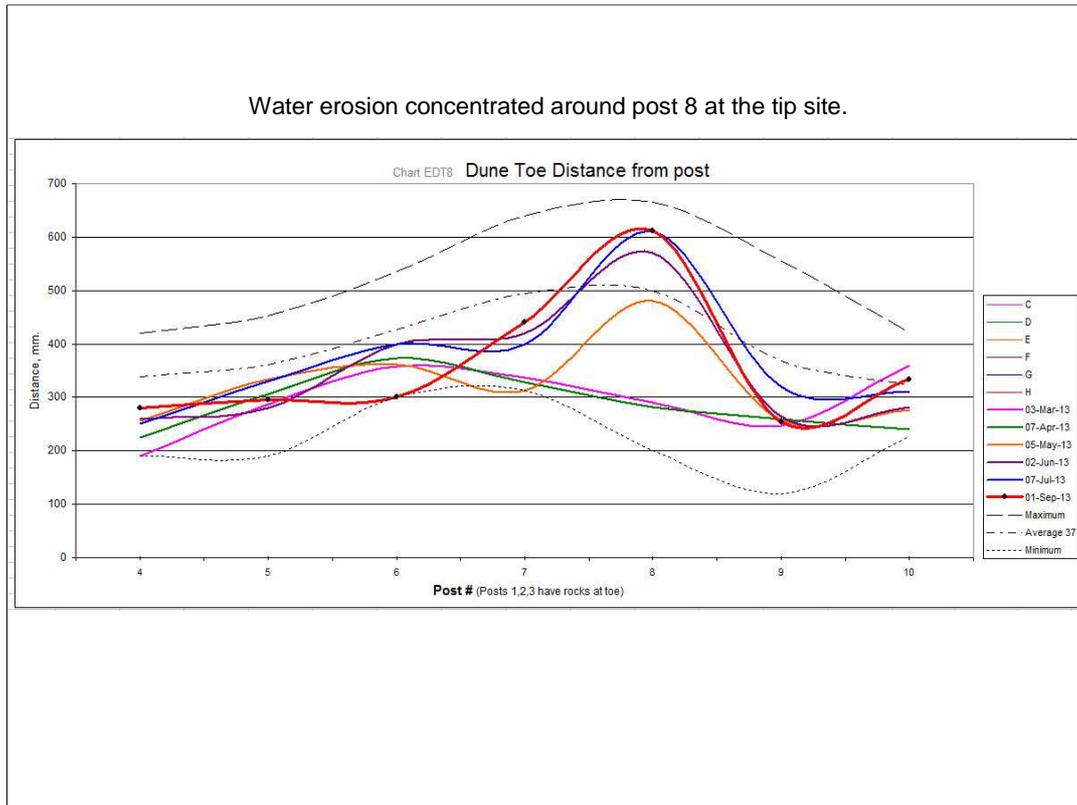
Over the next three months of toe measurements, there was confirmation of intense water erosion concentrated around the tip site at post 8.

The Moyne Shire investigated the old tip site and confirmed there was significantly less sand available to contain the tip contents. This disturbing finding initiated the design and construction of the Wave Energy Dissipation structure to protect the dune face and prevent the contents of the tip from entering the beach.

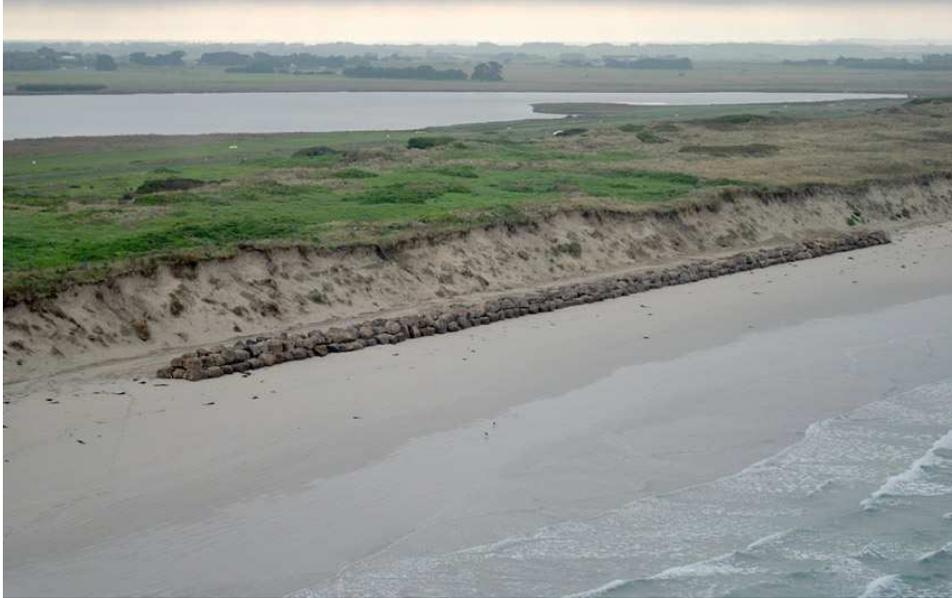
Wave Energy Dissipation structure May 2014

In response to the potential of a major dune breach, a special rock structure was designed and constructed to dissipate wave energy and protect the dune toe from further erosion.

The structure was completed a few weeks before the winter storm event in late June 2014.

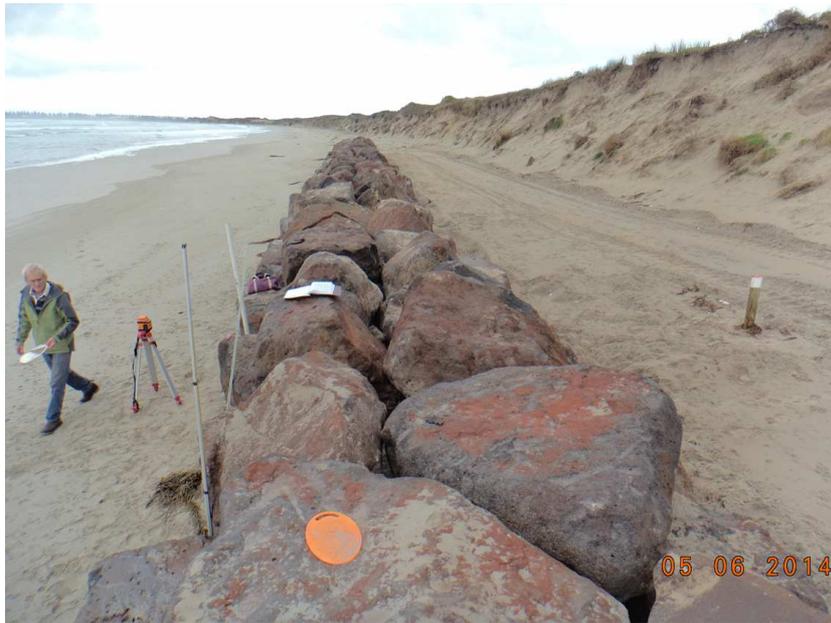
Storm protection for the old tip site - WEDs ver.1

The Wave Energy Dissipation structure installed during May 2014 is positioned well in front of the dune toe to provide maximum protection from waves penetrating the rocks.

PFCG members conducted an initial measurement around the rocks and then incorporated the measurement systems into future beach monitoring tasks.

Monitoring of the WEDs requires a total of 56 measurements and is accomplished by two separate teams where the monitoring is split up into transverse and longitudinal measurements; the latter being independent of the tide status.

Since this picture was taken, the dune toe has moved closer to post 8 with a great deal of sand added to the dune face and then stabilized with Enviro matting and replanted with native vegetation to retard wind erosion. Replanting of the dune face was a school project organized by the Moyne Shire. Not only has the dune face developed strong vegetation but plants have also appeared in the sand between the toe and the rock wall.

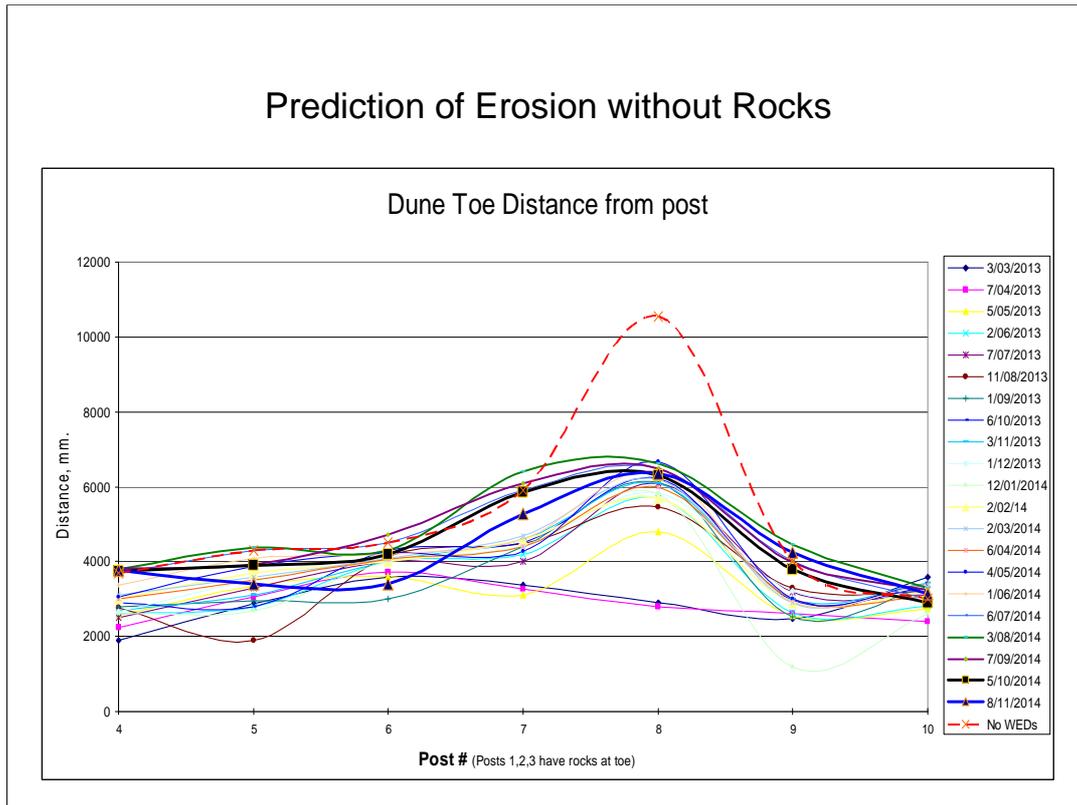
Prediction of Erosion without Rocks

By studying the historic relation between dune toe movements at posts 7, 8 and 9, it was possible to work out a correlation between changes in the dune toe distance at post 7 and dune toe changes at post 8.

Based on this correlation, the predicted sand loss at the post 8 dune toe could have been as large as 4m if the rock barrier had not been in place for the storm event in late July 2014.

It is estimated that a 4m dune recession would have been a serious breach and expose much of the tip contents to the beach.

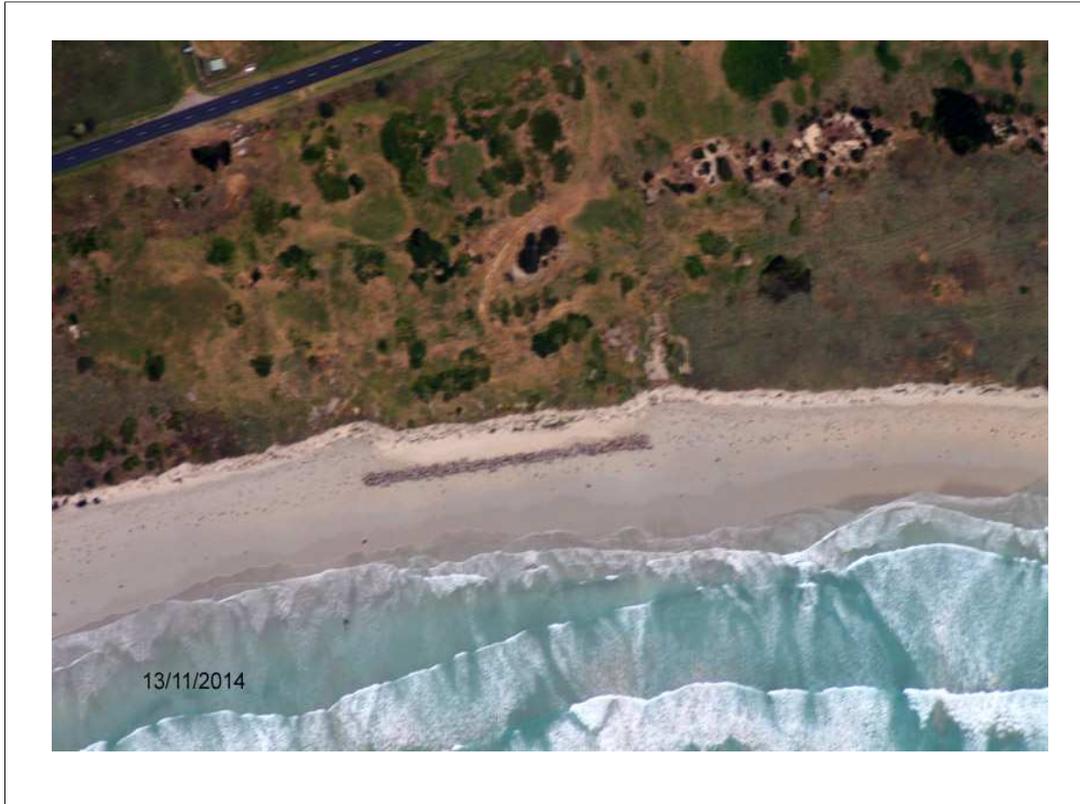
Five months after the storm event, this high altitude photograph clearly shows the large area of dry sand behind the wall, indicating sand height has been maintained for most of its length and protecting the dune toe from further water erosion.

Also visible is the increased dune erosion at the ends of the wall which was expected. Design changes were incorporated and included an increase in length to protect more of the tip site and the addition of double sand trap fences (known as Wattle and Wire, page 18) to minimise wash out at the wall ends.

All data indicates the wall was a successful prevention strategy.

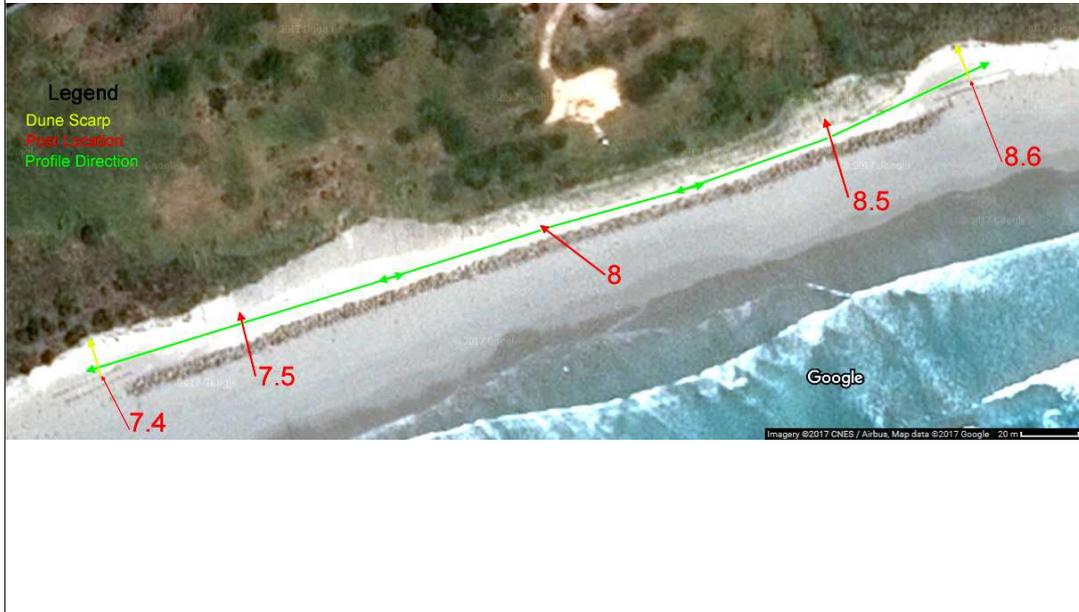
Wave Energy Dissipation structure - 2017

Rock wall extensions were completed in 2015 and included the double sand trap fences at each end. The sand fence has been very successful at minimizing erosion at the southern end but there is still activity visible at the northern end.

Assessment of the protection is monitored by measuring the sand height along the toe of the dune behind the rocks. Two additional posts (7.5 and 8.5) were installed by the Moyne Shire for this purpose and together with the existing post 8, allow sand height monitoring along 350m of protected dune toe.

A good quantity of dry sand is also visible behind the rocks in this Google image. Reference points 7.4 and 8.6 are posts that are part of the sand trap fences and are used to measure dune recession in the wash out areas with a laser distance measuring device.

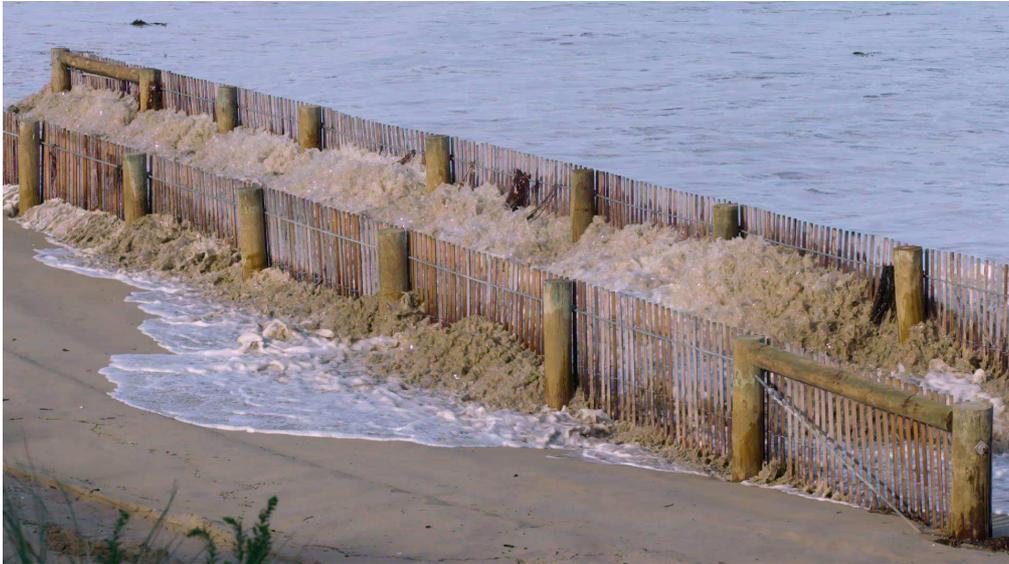
The double sand trap fences at work

Its effectiveness in reducing the wave surge is evident in the above image (Courtesy of PHP Productions from the video Defend Port Fairy).

Wave height is reduced as it passes through each fence so that in a relatively short distance, a large wave is reduced to low energy foam with insufficient energy to damage the dune toe. However, for very large waves that over top both fences, some of wave energy will reach the dune toe.

Sand trap fences are also designed to provide wind protection and work well in dry sand due to the special shape of the timber “pickets”. Each picket is a flattened diamond shape which is oriented side on to the prevailing water/wind and generates turbulence as the fluid passes between the pickets, almost independently of the angle of approach.

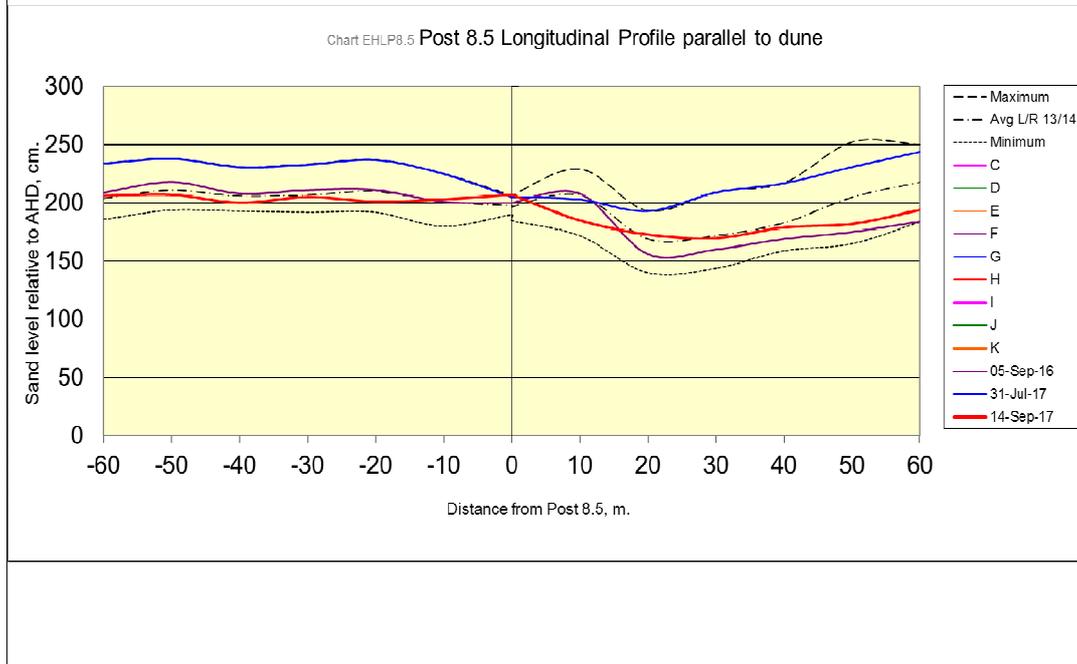
Sand Fence Performance Study – Northern End of the WEDs

A Wave Energy Dissipation structure usually causes concentrated dune toe erosion near its ends as wave fronts deflected by the face of the WEDs are displaced sideways and eventually accelerate around the end of the rock wall.

Sand monitoring from post 8.5 covers the northern end of the rock wall and the sand trap fences. There is more activity detectable at this end due to more aggressive wave action as can be seen in the earlier Google image of Port Fairy Bay, page 4.

In the above chart, the sand fences are approximately at the +40 to +60 metre position. The sand height from 12 months previous (purple graph) is about the lowest recorded and it extends behind the rock wall caused by the waves which flow around behind the wall. More recent measurements (The red and blue graphs) show that sand height has progressively returned. The lack of a sand peak in the recent graphs at the 10m distance are due to a new system of measurement adopted on 31/07/2017.

Previously, the 60m measurement to the right commenced at post 8.5 and followed rough ground whereas now it commences on flat sand mid way between post 8.5 and the rocks as shown on page 17.

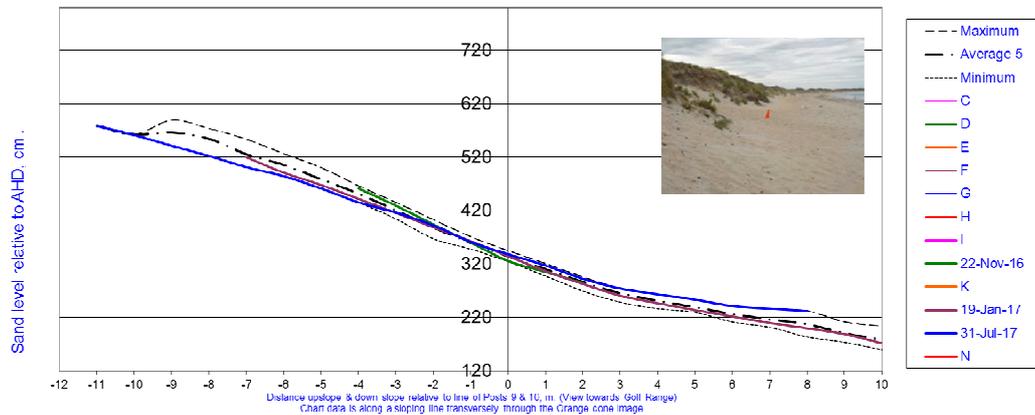
Chart EHTP 101 Post 10.1 - Parks Vic. Car Park Beach Gully Profile (Transverse)

Special monitoring is conducted at the 'gully' access to the beach from the Parks Victoria car park adjacent to the Golf Links.

In this case, extensive use of the gully to access the beach by horses has been studied over recent months. Particular interest centres on the transverse profile which shows the level of sand down the gully slope.

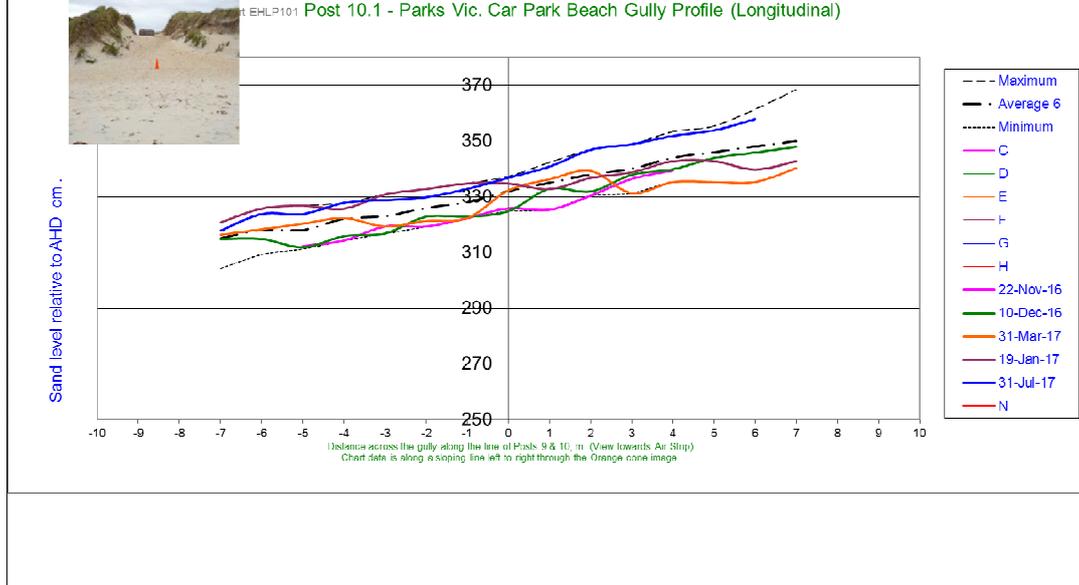
Parks Victoria Car Park Gully Monitoring

Longitudinal (*parallel to shoreline*) profile of special purpose monitoring at the car park gully. This shows the slope of sand in the gully from side to side at the extended reference point from posts 10 and 9.

Monitoring techniques are still being refined as measurement of sand height in the gully has unique difficulties. A major concern is the requirement to measure laser beam heights in excess of 4m above the beach.

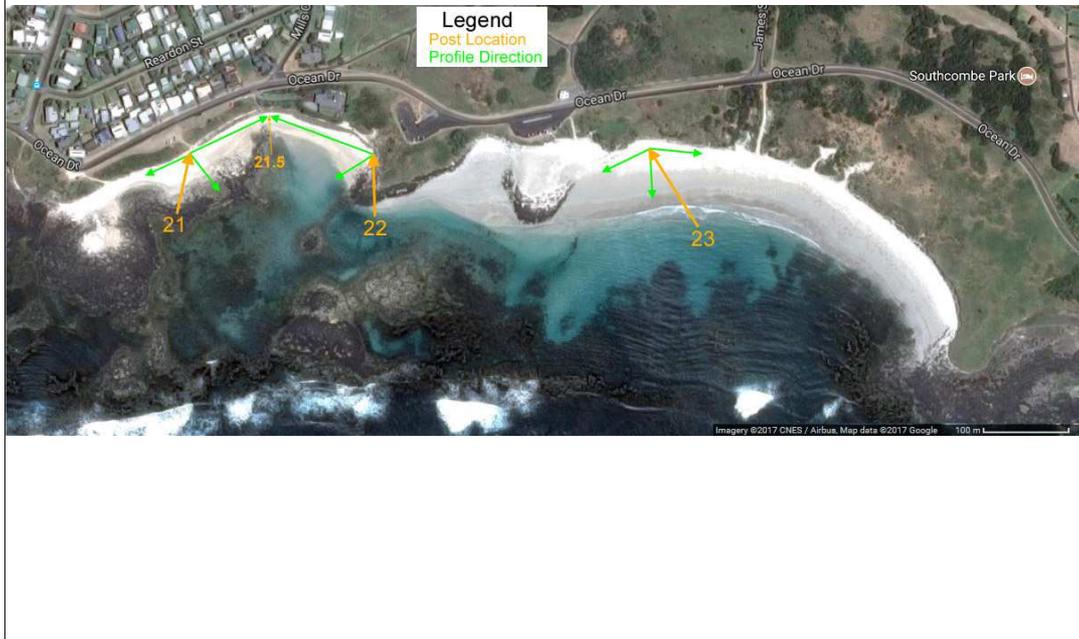
A year 6 science project for our two primary Schools

Posts 21, 22 and 23 are on the South coast beaches and are measured by students of Port Fairy's two Primary schools as part of their year 6 science programme sponsored by the Moyne Shire under the guidance of the Port Fairy Coastal Group.

Particular attention is given to the beach areas adjacent to rock wall protection between posts 21 and 22. Longitudinal profiles monitor sand height in front of the rocks and transverse profiles monitor sand height down to the water's edge.

In general, South beach monitoring shows the effectiveness of the natural off shore reefs in reducing the impact of normal wave action on beach erosion however, it is more susceptible to damage from storm surges due to the low flat area with houses in close proximity to the beach.

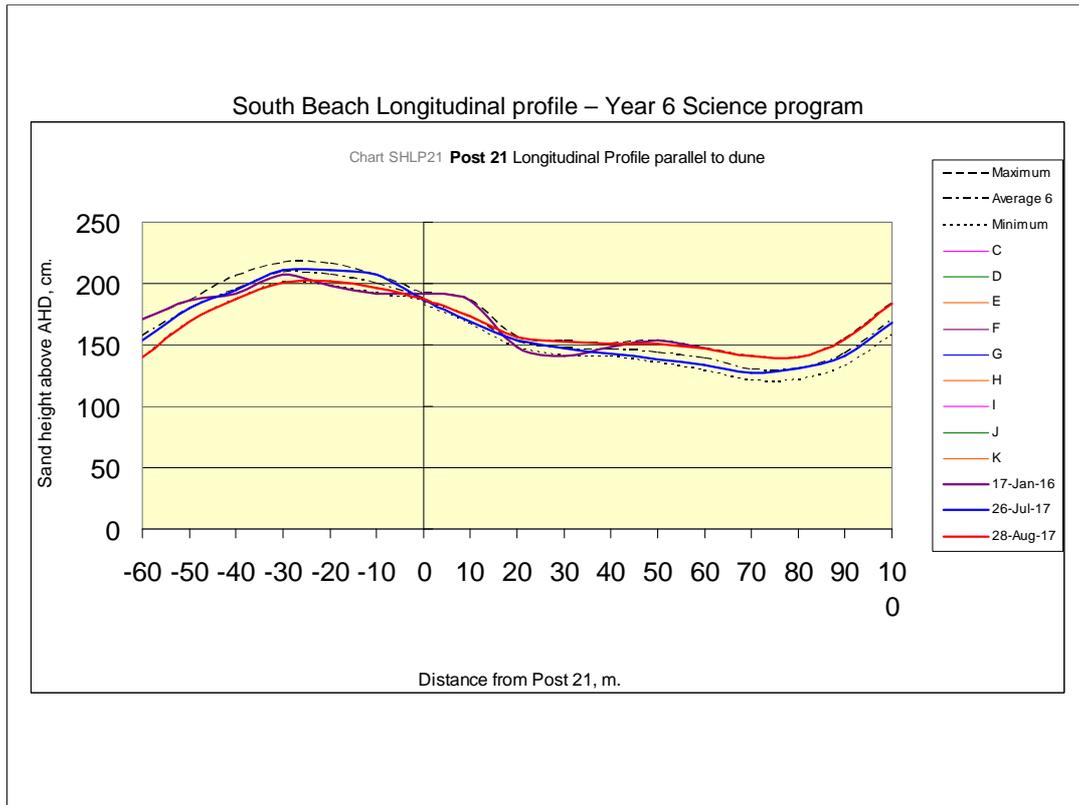
The available beach in this area is reduced by extensive outcrops of rock that also provide natural protection from water erosion.

While our data on South beach is not as comprehensive as East Beach, our measurements have shown these areas to be more stable than any part of East Beach but the potential for storm surge inundation still exists in the low lying areas of Ocean Drive.

The right half of the profile chart plots sand height in front of a recently installed rock wall protecting the dune face. Regular measurements conducted by the year 6 students under the guidance of the Port Fairy Coastal Group give advanced warning of any changes in sand conditions.

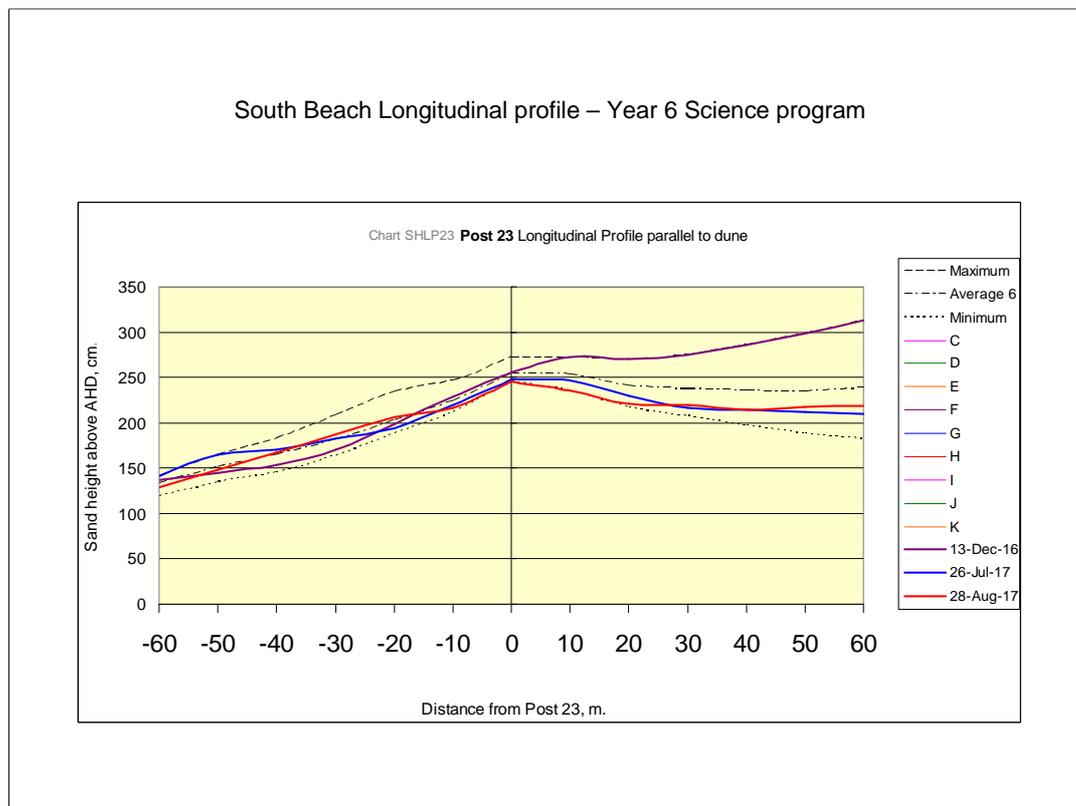
South Beach Longitudinal profile – Year 6 Science program

Longitudinal profiles are height measurements parallel to the dune face and sensitive to water and wind erosion. This area (also known as the dog beach) has a large expanse of relatively flat sand and is very popular with locals and their dogs.

Data from the transverse profiles indicate this area is slightly more active in the foreshore area than other parts of the South coast that we monitor.

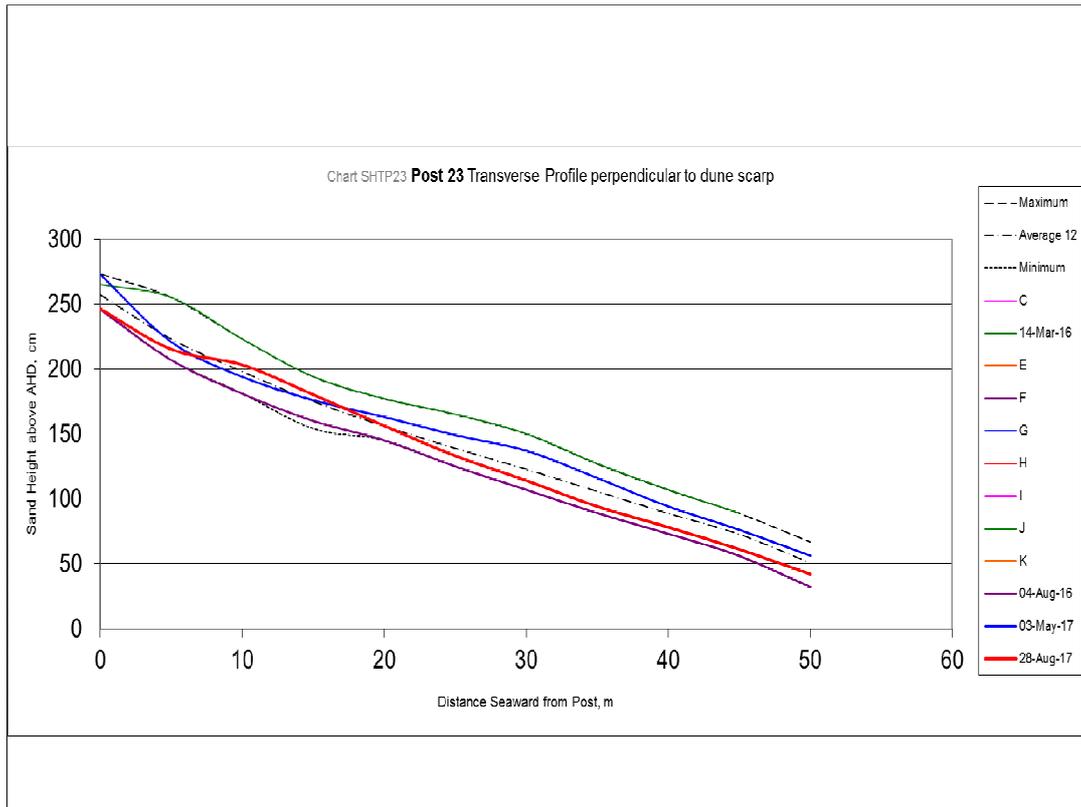
A Transverse (*from the post to water's edge*) profile for South Beach indicates a little more activity than at Pea Soup beaches, probably due to this beach being slightly more exposed as the rocks are further from the shore.

Measurements to a 50m distance from the post are common and reflect the large and relatively flat sand area that make the location so popular for dog walking.
